Subcutaneous Emphysema after Pacemaker Insertion

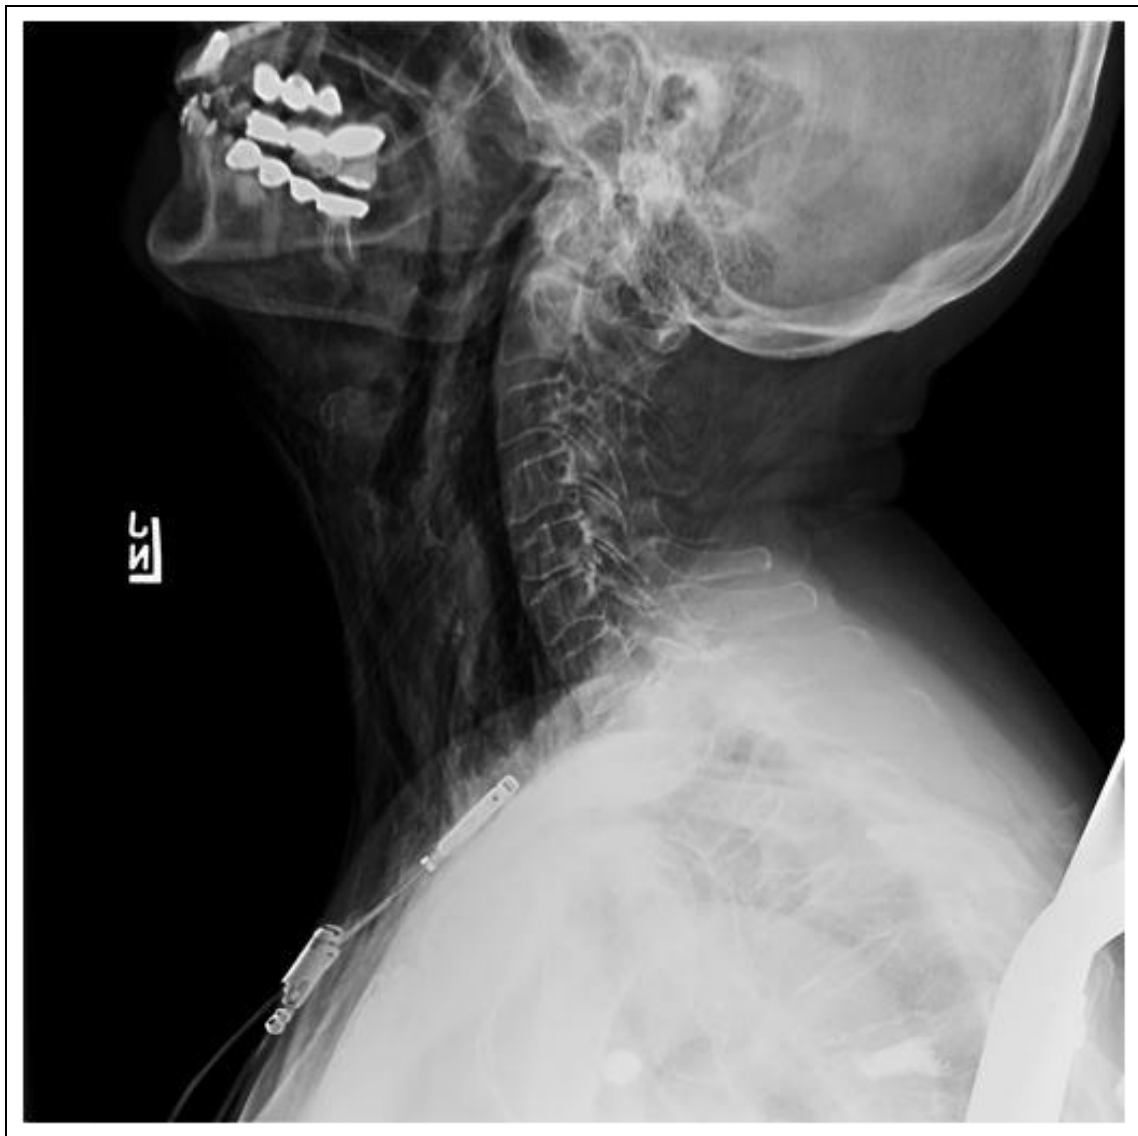
The patient had a 2D-echocardiography (ECHO) which showed ejection fraction of 55-60%, normal ventricular size, wall thickness and systolic function. It was then decided to take her up for a pacemaker insertion. On day 2 of hospitalization, she had a dual chamber pacemaker device (magnetic resonance imaging compatible) inserted via subclavian vein puncture with use of active fixation leads for both atrial and ventricular pacing. The procedure was unremarkable without complications. The next day, the patient complained of chest tightness, neck pain, and facial swelling. Chest x-ray (CXR) was done which only showed a small left apical pneumothorax. Electrocardiogram (EKG) was unremarkable. Subsequent days, since pain and swelling did not subside, CXR and lateral neck radiographs were performed two days later which showed bilateral worsening subcutaneous emphysema with small left-sided pneumothorax as shown in Figure 1.

The patient was monitored over the next few days and subcutaneous emphysema was gradually reduced with conservative treatment confirmed by serial radiographs. Pacemaker interrogation revealed no change in lead data.
